Manhole Inspection Summary

Manhole # S37C__022MH

Insp Date: **3/26/09 1:35 PM**

Location Address: **CITY IMPOUND LOT @ FALLSWAY** Cross Street: **E PLEASANT ST**

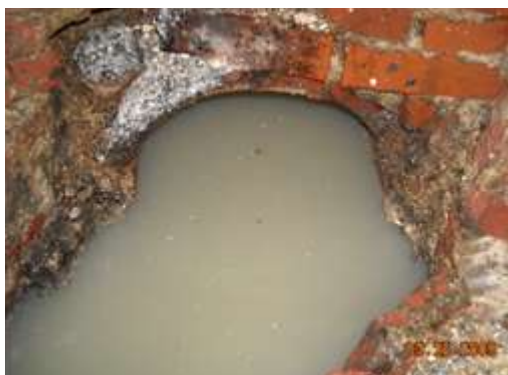
Defect 5

Condition: ☐ Sound ☐ Cracked ☐ Root Intrusion ☒ **Deteriorated** ☐ Leaks ☒ **Debris**

DETERIORATING CHANNEL AND BENCH

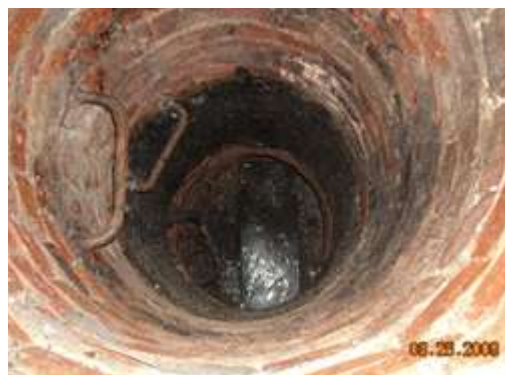
Defect 4

Steps Count: **8** Missing: **0** ☒ **Corroded**

Surcharge ☒ **Evidence Of Surcharge** Depth: **8** (ft.) ☐ Active Surcharge Present

EVIDENCE OF SURGE;
SURGE RING, CORRODED
STEPS

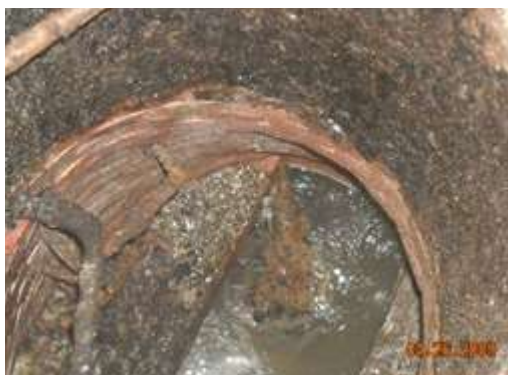
Defect 3

DEBRIS IN CHANNEL

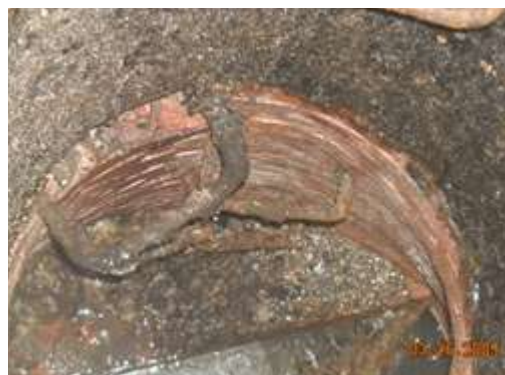
Defect 2

DEBRIS ON BENCH

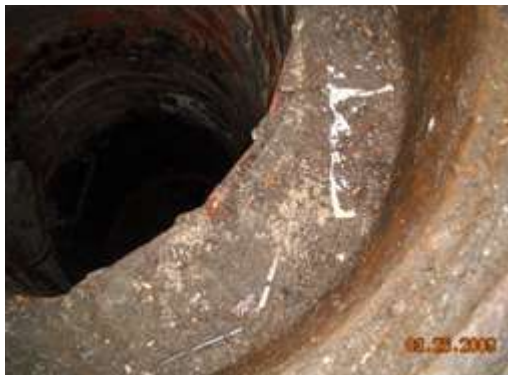
Defect 1

Frame Offset: **6** (in.) Condition: ☒ Sound ☐ Cracked ☐ Leaks

FRAME OFFSET

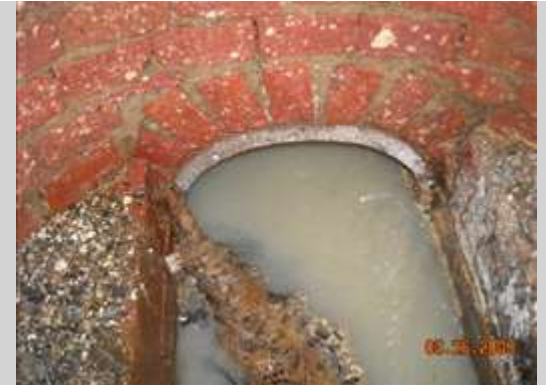
12 O'Clock Outflow

15 in. Circular Gravity Sewer
Pipe Out @ 12 O'Clock

Pipe Height: **15.6** (in.) Rod and Bar (Angled)
Pipe Material: **Clay** ☐ Pipe Lined
Invert Depth: **13.40** (ft.) Flow Characteristics: **Slow**
Deposits: ☐ None ☒ **Mud** ☐ **Grassy** ☒ **Debris** ☐ Grease
Silt Depth: **6** (in.) Deposits Extent: **Medium**
Infiltration: **None** Pipe Seal Cond: **Sound**

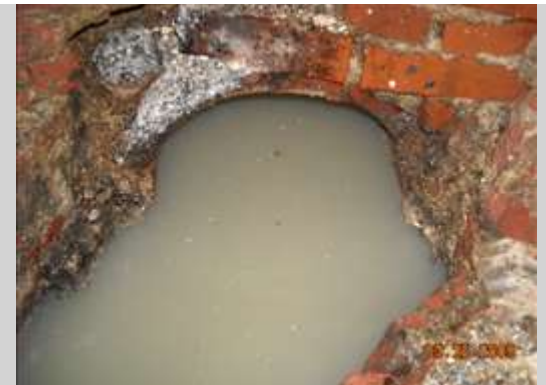
5 O'Clock Inflow

15 in. Circular Gravity Sewer
Pipe In @ 5 O'Clock

Pipe Height: **15.6** (in.) Rod and Bar (Angled)
Pipe Material: **Clay** ☐ Pipe Lined
Invert Depth: **12.80** (ft.) Flow Characteristics: **Slow**
Deposits: ☐ None ☒ **Mud** ☐ **Grassy** ☐ Debris ☐ Grease
Silt Depth: **2** (in.) Deposits Extent: **Light**
Infiltration: **Evidence** Pipe Seal Cond: **Broken**

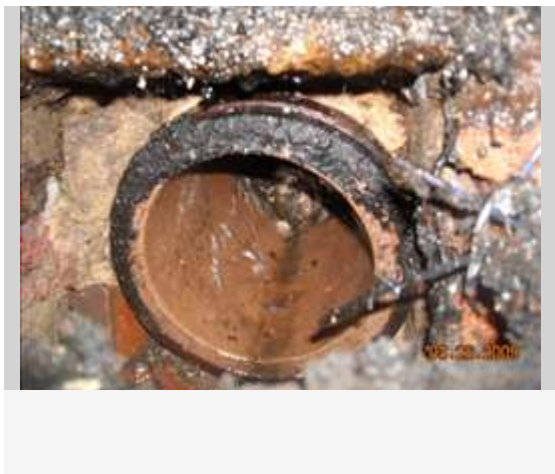
9 O'Clock Inflow

8 in. Circular Gravity Sewer
Pipe In @ 9 OClock

Pipe Height: **8.4** (in.) Rod and Bar (Angled)
Pipe Material: **Clay** ☐ Pipe Lined
Invert Depth: **7.10** (ft.) Flow Characteristics: **Slow**
Deposits: ☐ None ☐ Mud ☒ **Sludge** ☐ Debris ☐ Grease
Silt Depth: **1** (in.) Deposits Extent: **Light**
Infiltration: **Evidence** Pipe Seal Cond: **Sound**
